**Victorian Society Testimony for February 11, 2025: 184 7th Avenue South (LPC-25-03324); 261 11th Avenue (aka 261-279 11th Avenue, 220-238 12th Avenue, 601-651 West 27th Street, and 600-654 West 28th Street) (LPC-24-06372); 893 Broadway (LPC-25-04503); 120 Riverside Drive and 125 Riverside Drive (LPC-25-02231 and LPC-24-04259); 222 West 79th Street (LPC-24-07356); Verdi Square Scenic Landmark (LPC-25-06032)**

**LPC-25-06032 -- Verdi Square - Scenic Landmark, Manhattan**

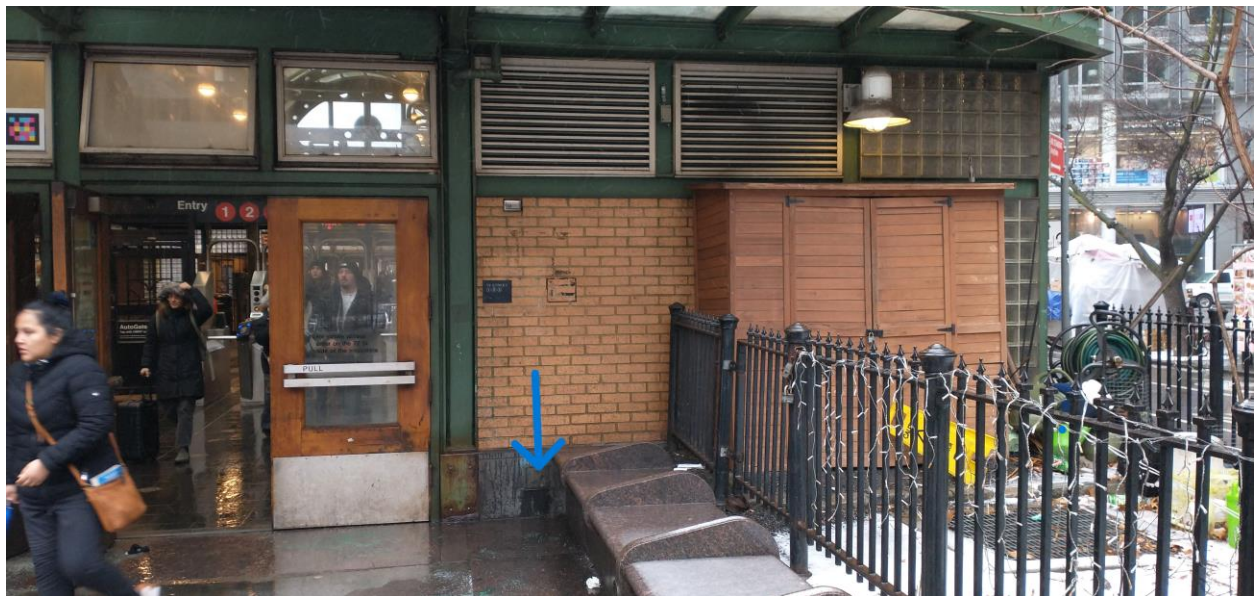
*The blue arrow shows the hose bib box on the north side of the new station entrance. This is immediately adjacent to the west planting bed, on the right. There is a second hose bib on the south side, closer to the scenic landmark part of the site.*

The scenic landmark constitutes a small part of the open space around the subway entrance. With all this available undesignated space, we're puzzled at the decision to locate the backflow preventer within the scenic landmark. More puzzling is the failure to make use of two existing hose bibs on the exterior of the station building. These were intended to provide water for the plaza and plantings, one of them being just two feet from the west planting bed. If the MTA has been reluctant to allow use of this water source, perhaps a call by the Parks, or even the Landmarks commissioner to an appropriate colleague at MTA would solve this problem and avoid the cost, disruption, and visual intrusiveness of the proposed backflow preventer and waterline installation.

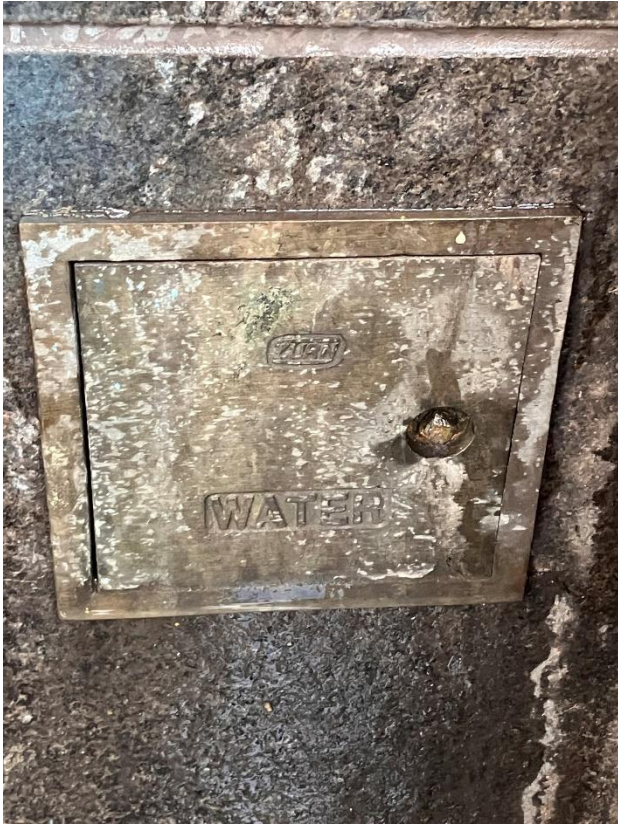
*Close up of the box, clearly labeled "WATER."*

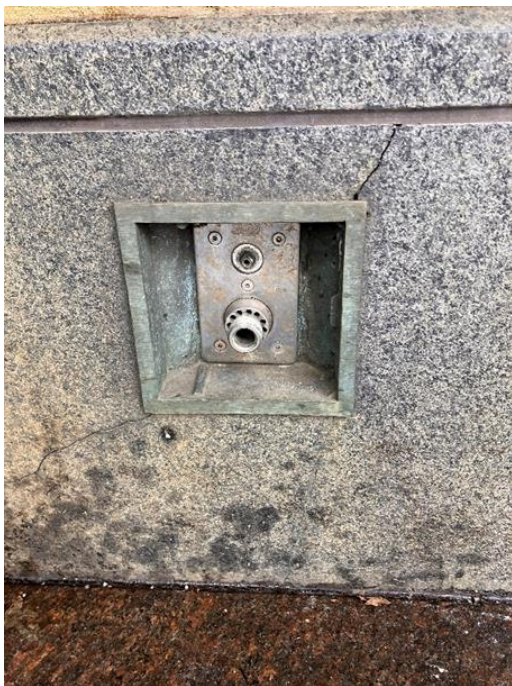
*Hose bib on the south side of the station building.  
The missing cover shows the standard hose connection  
And valve. This hose bib is 40 feet from the scenic landmark.*

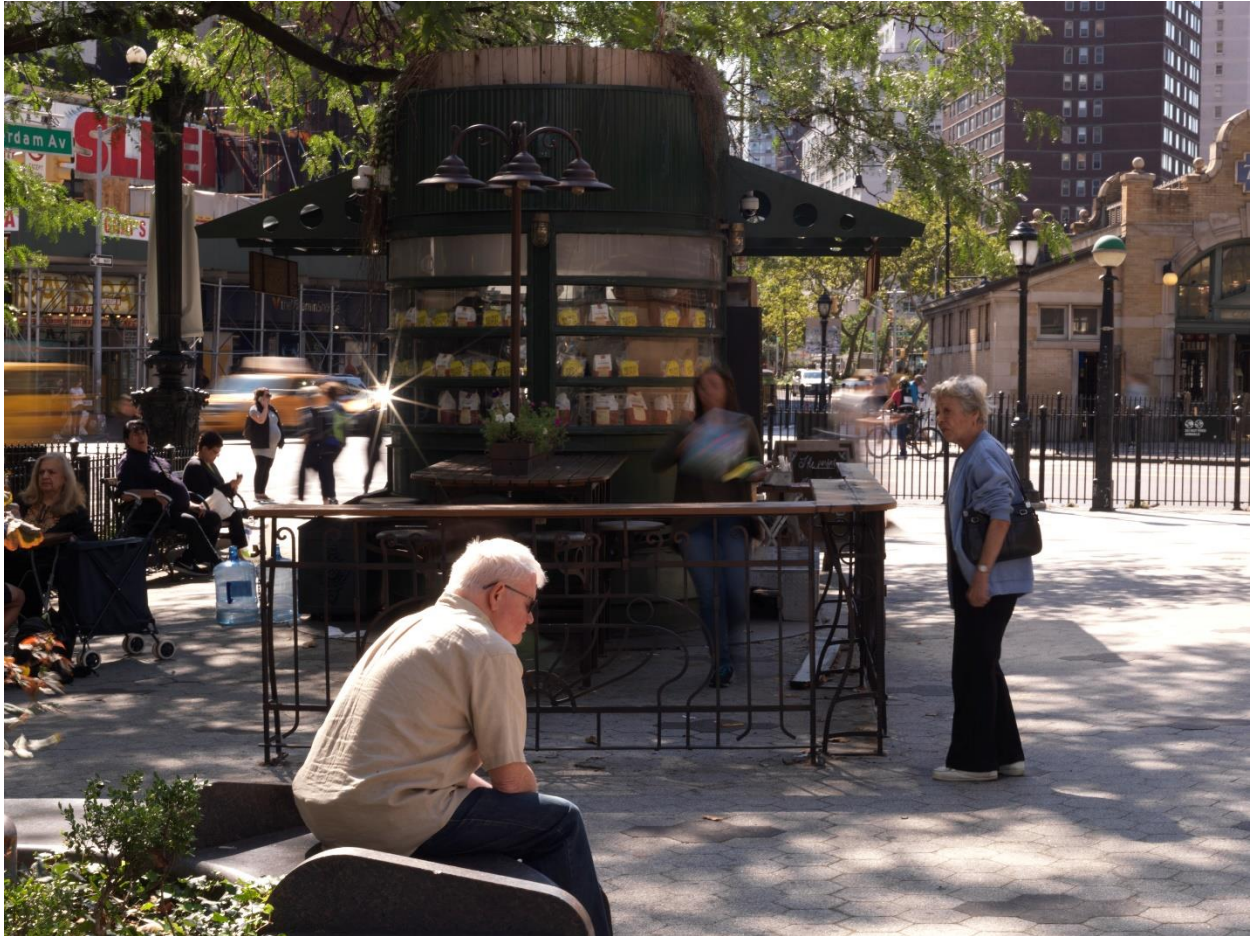
*Parks' food service kiosk, which has a water supply. A simple and inexpensive alteration could add a hose bib to the back of the kiosk on the left, facing the Verdi Square planting bed, just 10 feet away.*

If even this is too much to ask, we note that a Parks Department food service kiosk is located just 10 feet from the scenic landmark. It has water service, and a quick and inexpensive modification could bring a hose bib to the back of that structure, with easy access to Verdi Square.
